Toucan crossings for cyclists and pedestrians

Project Report 47
H5/10D

TOUCAN CROSSINGS FOR CYCLISTS AND PEDESTRIANS

**Prepared for: Project Record: H5/10D Safety Measures for Cyclists
and Pedestrians**
Customer: Traffic Policy Division, DOT (Mr E Wyatt)

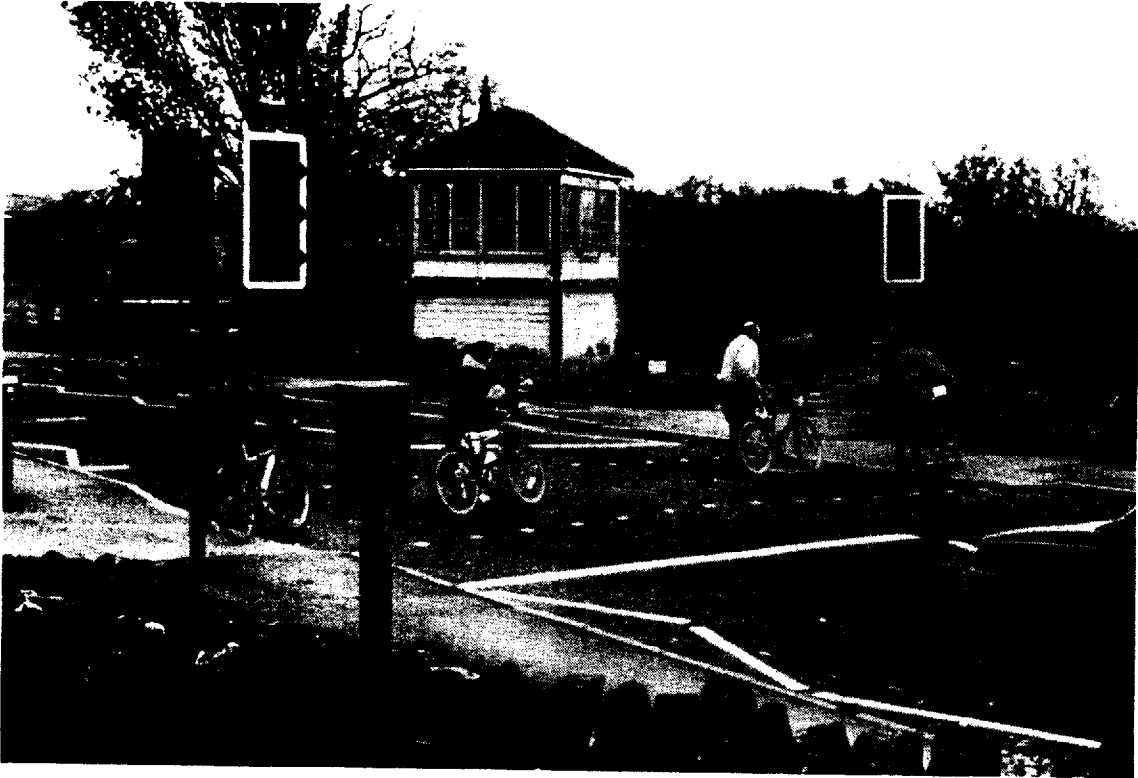
Plate 1 Bristol: A420/railway path, Warmley (Avon County Council)

1 Bristol: A420/railway path, Warmley (Avon County Council): conversion of a Pelican Crossing connecting the cycle/pedestrian railway path across the A420 at Warmley High Street, Bristol. The 4m wide crossing is used mainly by people on recreational trips and is most heavily used at the weekends. The carriageway is 9.0m wide.

The TOUCAN has an unsegregated cycle/pedestrian path approach on both sides. The 'Zig-Zag' markings associated with the Pelican had not been removed at the time when the crossing was studied.

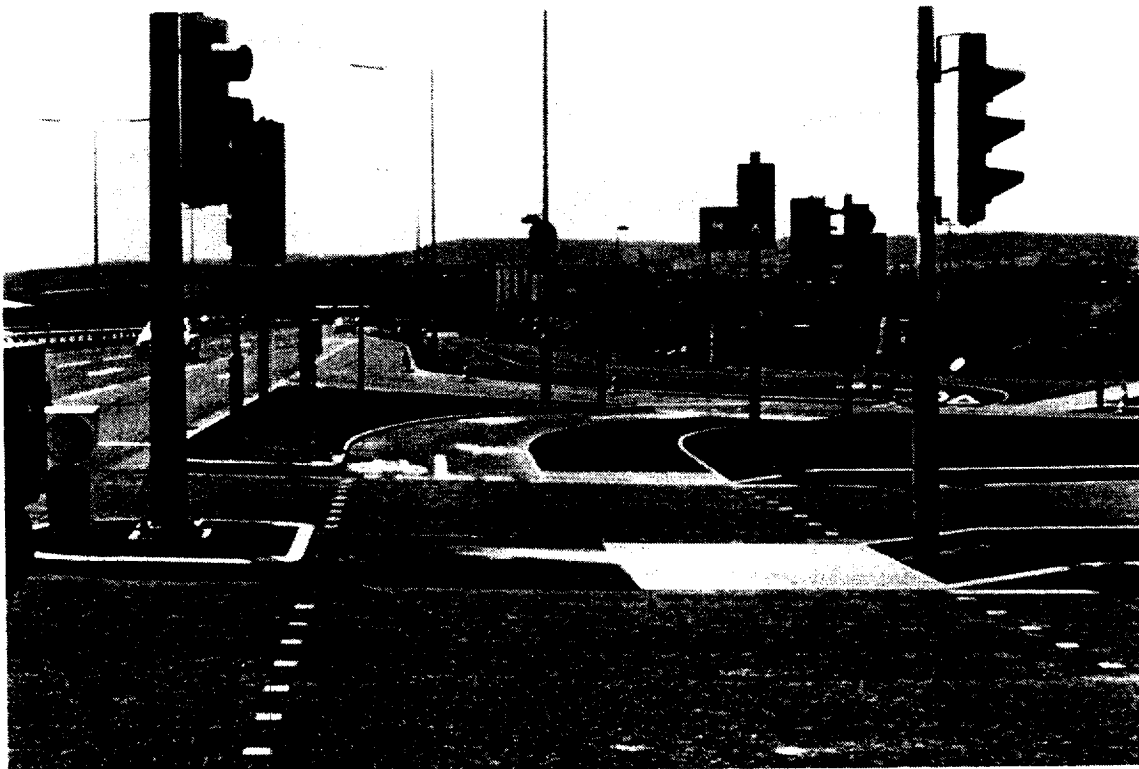
Plate 4 Exeter: Rydon Lane/Pynes Hill (Devon County Council)

4 Exeter: Rydon Lane/Pynes Hill (Devon County Council): four crossings of the newly constructed entry and exit lanes of a new office development at Pynes Hill, off Rydon Lane, near to the grade-separated junction with the A379. There are perpendicular approaches to all TOUCAN crossings. These approaches are segregated by a difference in level between a cycle track and footway, each 2m wide, right up to the edge of the carriageway. The widths of the four carriageways, all one-way, are 5.5 to 6.5m. There are also centrally positioned buttons to further emphasize the segregation. Both of these design features are contrary to the advice given by the Department of Transport since they tend to

induce segregated use of what was intended to be a shared crossing. Devon County Council produced imaginative publicity material for the opening of their TOUCAN crossings as shown in Fig 2.

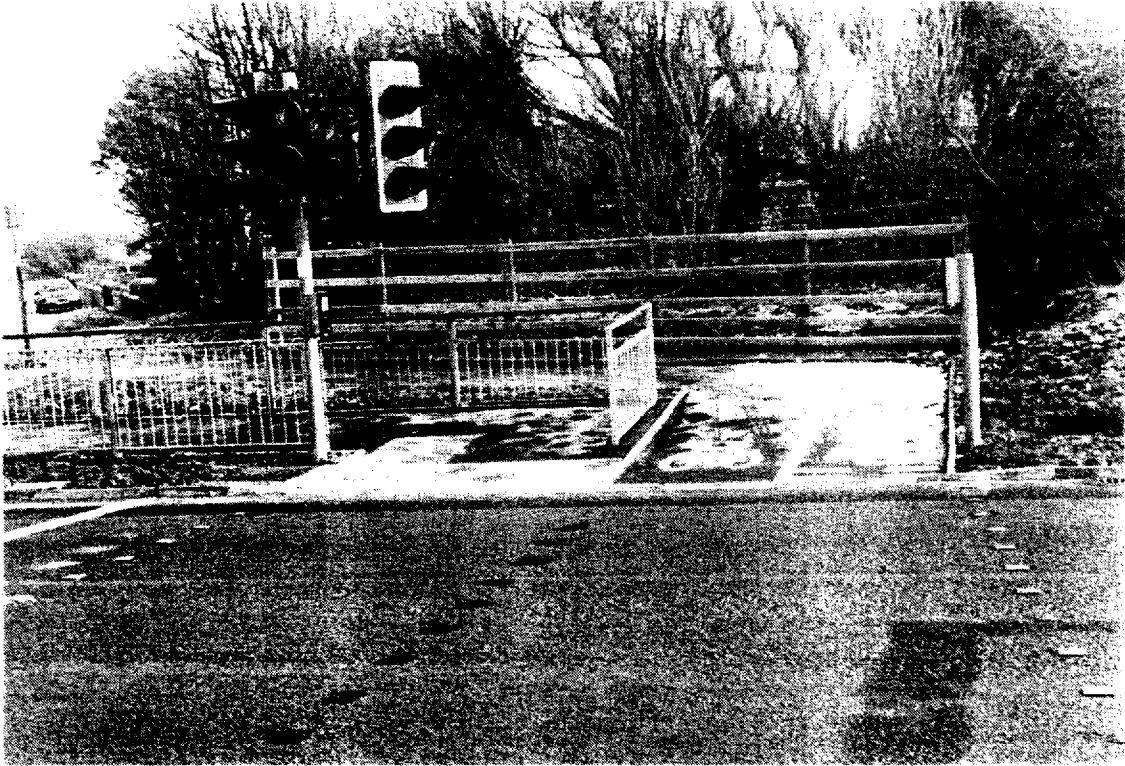
**Plate 7 Cleveleys, nr Blackpool: A585(T) Amounderness Way/Linden Avenue
(Lancashire County Council and North West Regional Office, DOT)**

7 Cleveleys, nr Blackpool: A585(T) Amounderness Way/Linden Avenue (Lancashire County Council and North West Regional Office, DOT): conversion of a Pelican Crossing of Amounderness Way near the junction with Linden Avenue. Segregated cycle and pedestrian paths, both 2m wide, with perpendicular approaches were constructed on both sides of the crossing. Close to each side of the crossing, the tracks were built with 'dog legs' (two right-angled bends) and guard rails. The single carriageway is 7.4m wide. This is the only Trunk Road site in the TOUCANs trial. It was funded by the Department of Transport Regional Office (North West Network Management Division, Manchester).

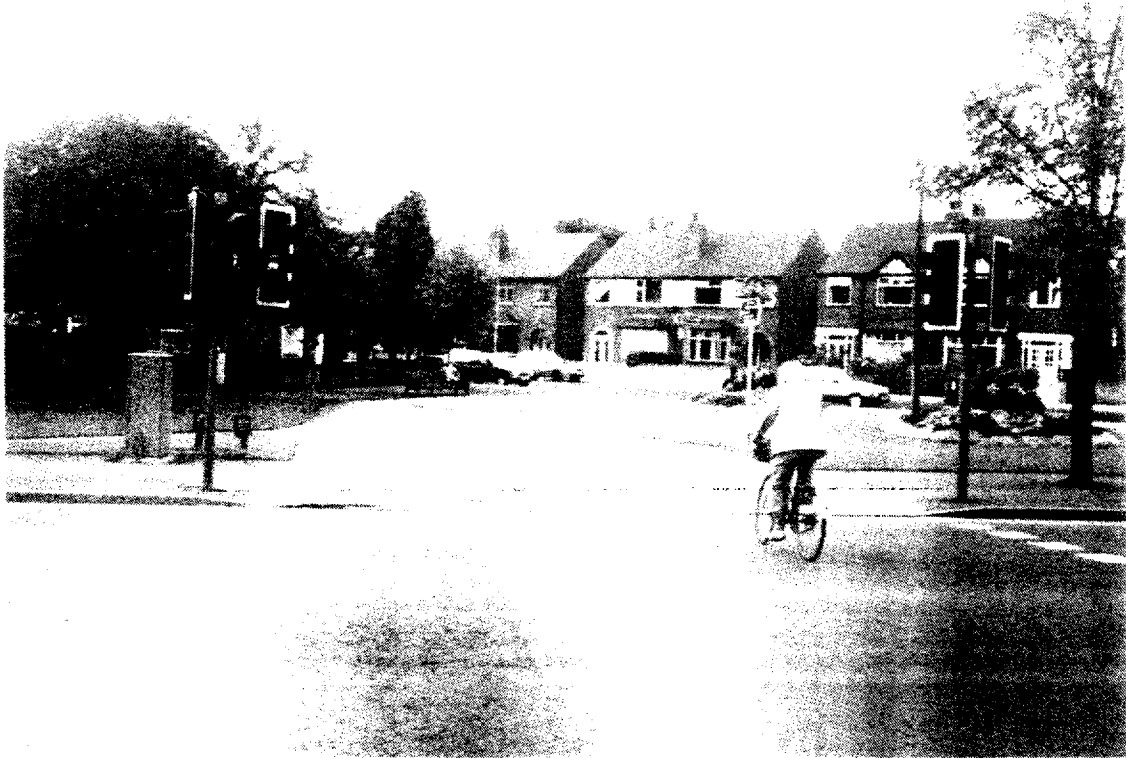
Plate 8 Nottingham: Queens Road, Beeston (Nottinghamshire County Council)

8 Nottingham: Queens Road, Beeston (Nottinghamshire County Council): conversion of existing cycles-only crossing on Queens Road. On one side, the cycle track approaches perpendicularly, on the other, there are both a perpendicular approach and a cycle track parallel to the road. Push buttons replaced the inductance loop detection of cycles.

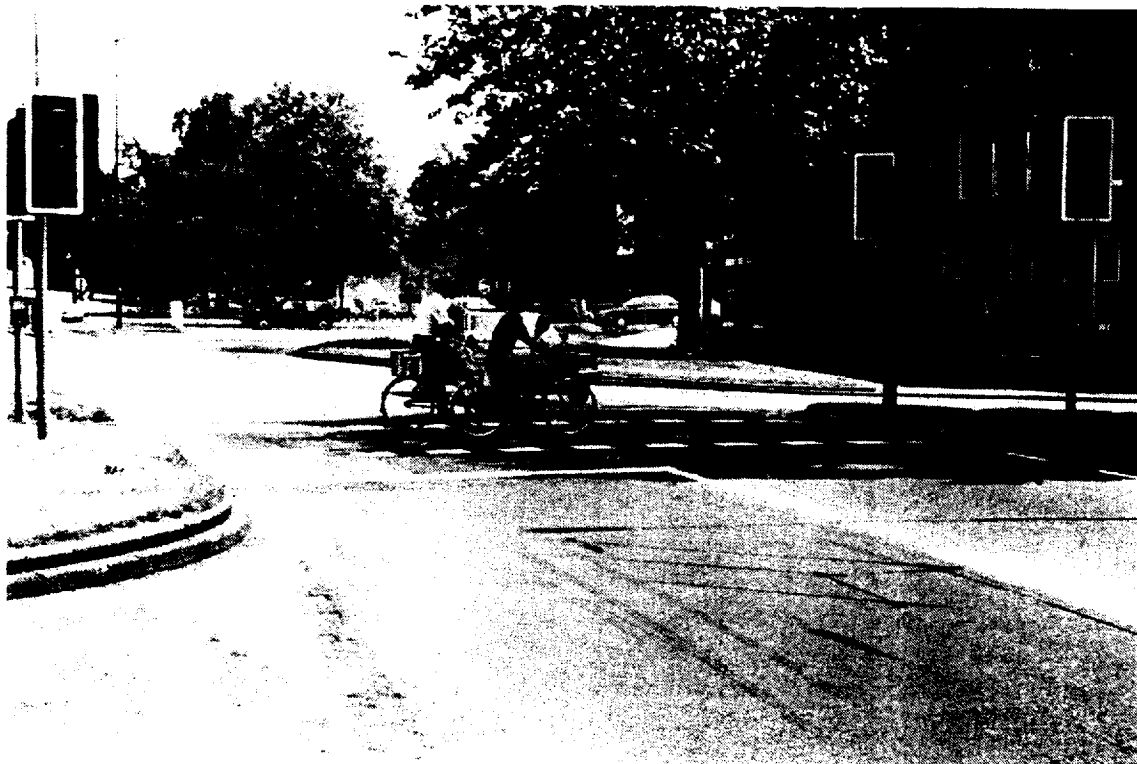
Plate 9 Nottingham: Sherwin Road (Nottinghamshire County Council)

9 Nottingham: Sherwin Road (Nottinghamshire County Council): conversion of existing cycles-only crossing on Sherwin Road. A cycle track parallel to the road switches to the other side of the road at the crossing. Push buttons replaced the inductance loop detection of cycles.

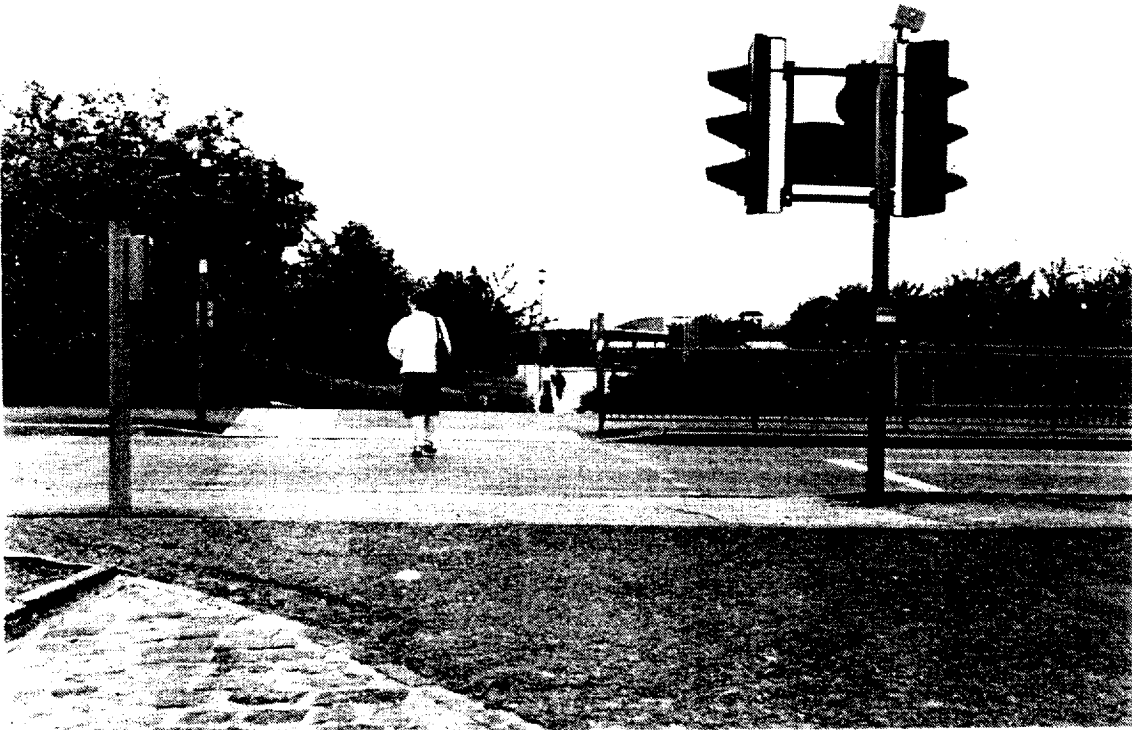
Plate 11 Clydebank: Argyll Road (Strathclyde Regional Council)

11 Clydebank: Argyll Road (Strathclyde Regional Council): conversion of a Pelican Crossing on Argyll Road with unsegregated cycle/pedestrian tracks approaching perpendicularly on both sides. The crossing is 4m wide, the carriageway 7.3m.
